SECTION 8

OV-102 (STS-87) TPS Damage

Date: April 2, 1998
No.: 270-200-98-017
To: J. T. Hughes
RSS - Downey
D/270-200, 841-AC85
From: M. L. Helsel, V. H. Bui
RSS - Downey
D/270-200, 841-AC85
Subject: **TPS Damage Assessment of STS-87 and STS-89**

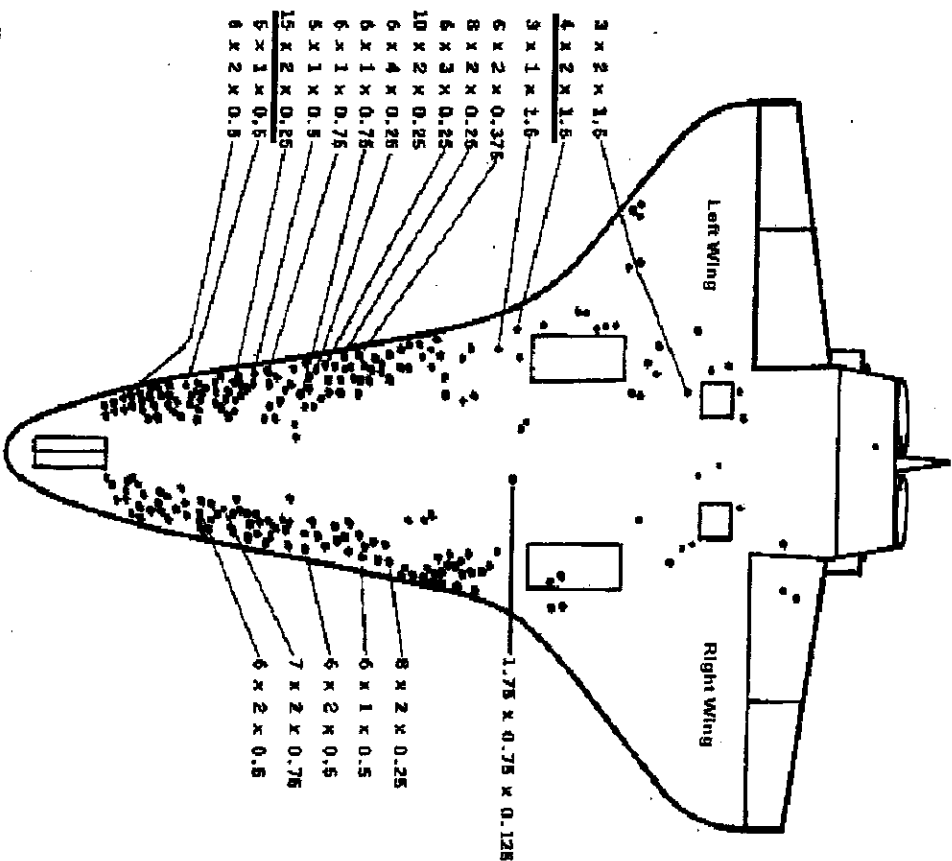
Lower Surface Tile Damage

- OV-102 TPS Sustained a Total Of 308 Hits During STS-87
 - Lower Surface had 244 Hits with 109 Hits > 1" in Length
- Major Damage Area on the Lower Surface Is Between the Nose Landing Gear and Main Landing Gear Doors
 - Largest Damage Located on the Glove Measuring 15"x 2"x.25"
 - Deepest Damage Located Forward of Left Main Gear Door Measuring 4"x 2"x1.5"

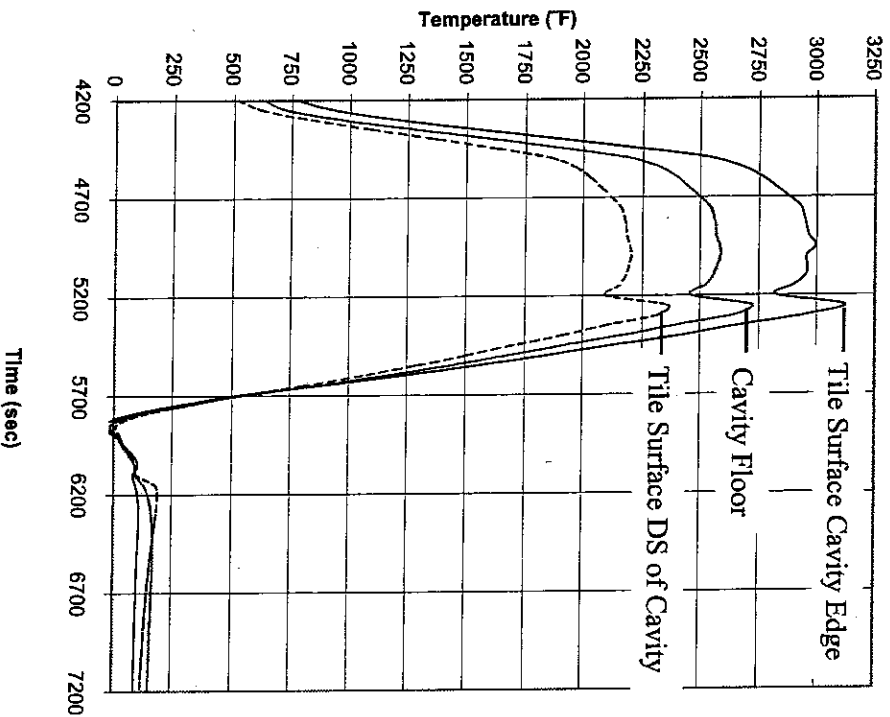
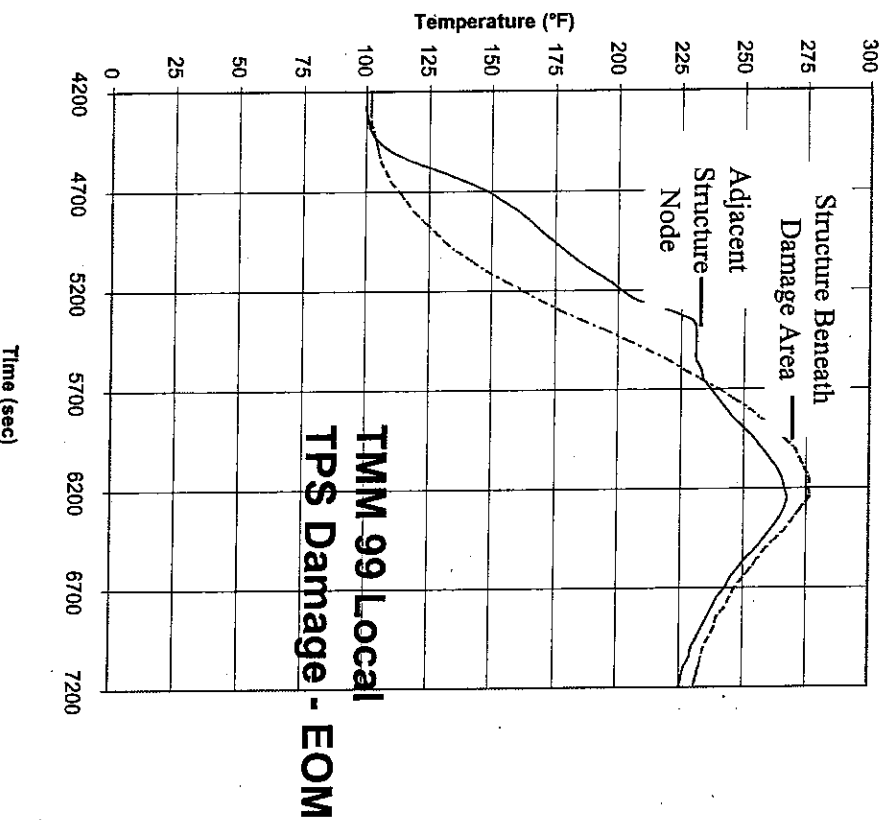
Temperatures Indicate TPS Surface Damage; Structure Okay

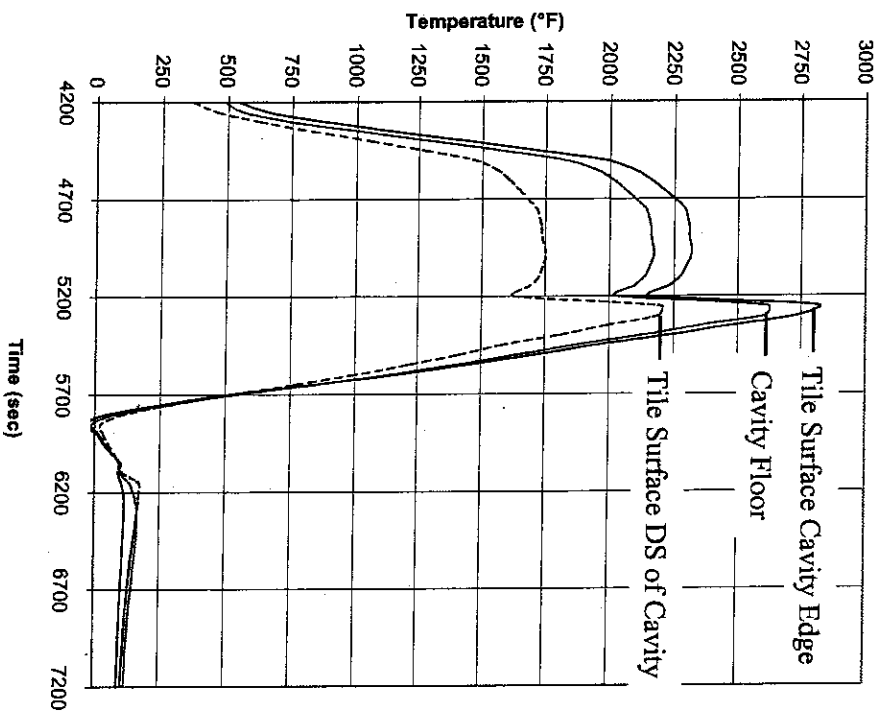
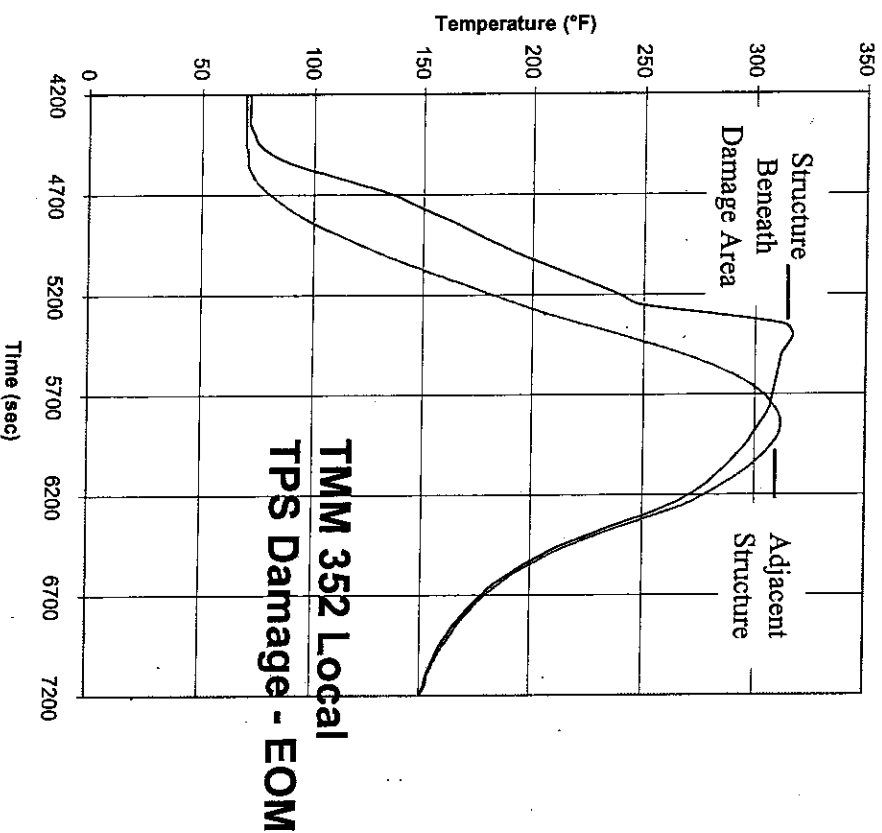
**TMM 352 Local
TPS Damage - EOM**

Local TPS Surface Damage Expected; Structure Acceptable

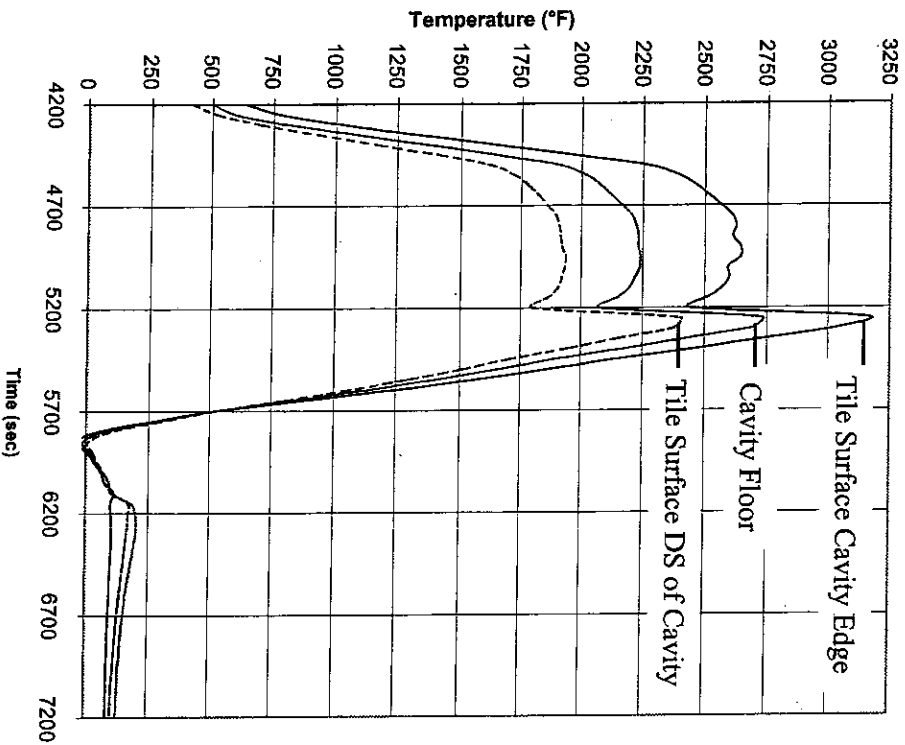
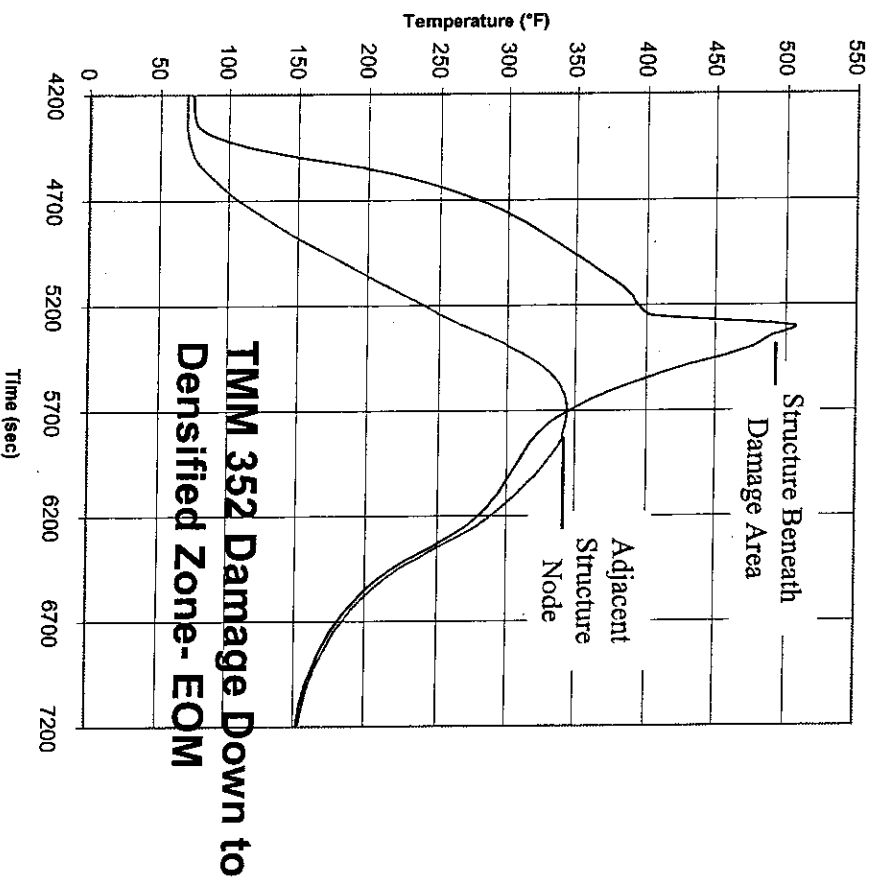
Tile Damage to Densified Zone Produces Structural Damage

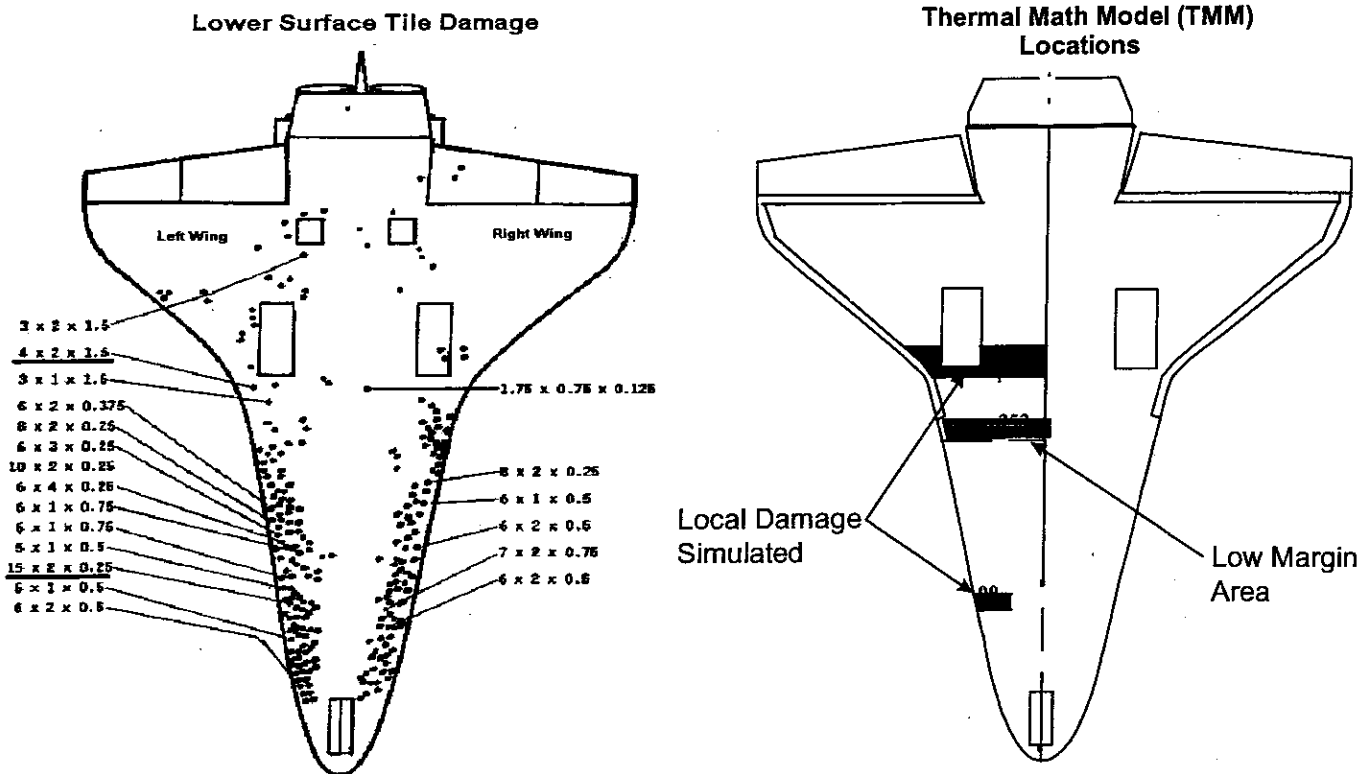
Figure 1 - Model Locations Chosen to Analyze Worst Damage Sites

To analyze the temperatures experienced by the OV-102 lower surface TPS, mission specific aeroheating was generated for EOM, and existing thermal math models (TMMs) were selected which covered the two worst damage areas. (See Figure 1). TMM 99, located on the lower wing glove, was chosen to simulate one of the longer damage sites, and TMM 352, located near the left main landing gear door, was chosen to cover the site of the deepest damage.

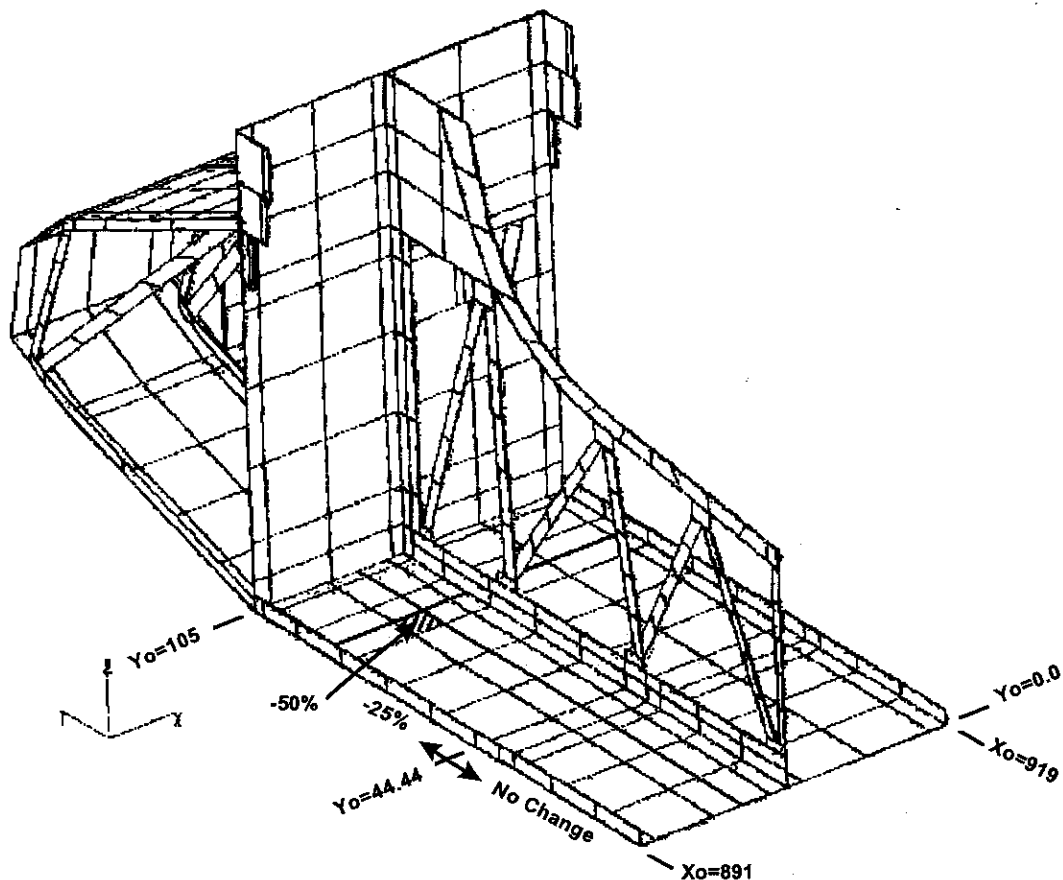
Figure 7 - Simulated Damage Location on TMM 353

Structural analysis identified temperature gradients at the bottom panel from the centerline to the side wall of the mid-fuselage bottom at Xo1050 as a critical margin area. TMM 353 was chosen to simulate extensive damage in this area. The analysis considered a 25% tile loss over one frame bay of the bottom. Within this area, one tile was reduced to 50% thickness. See Figure 7.

Evaluation of extensive damage on the outboard lower surface using TMM 353 indicated minimal tile damage. However, the structural temperatures and temperature gradients exceeded acceptable limits. The temperature results of this analysis were assessed by the structures group and their conclusion was that large in-plane gradients and thermal stresses result in unacceptable margins of safety.

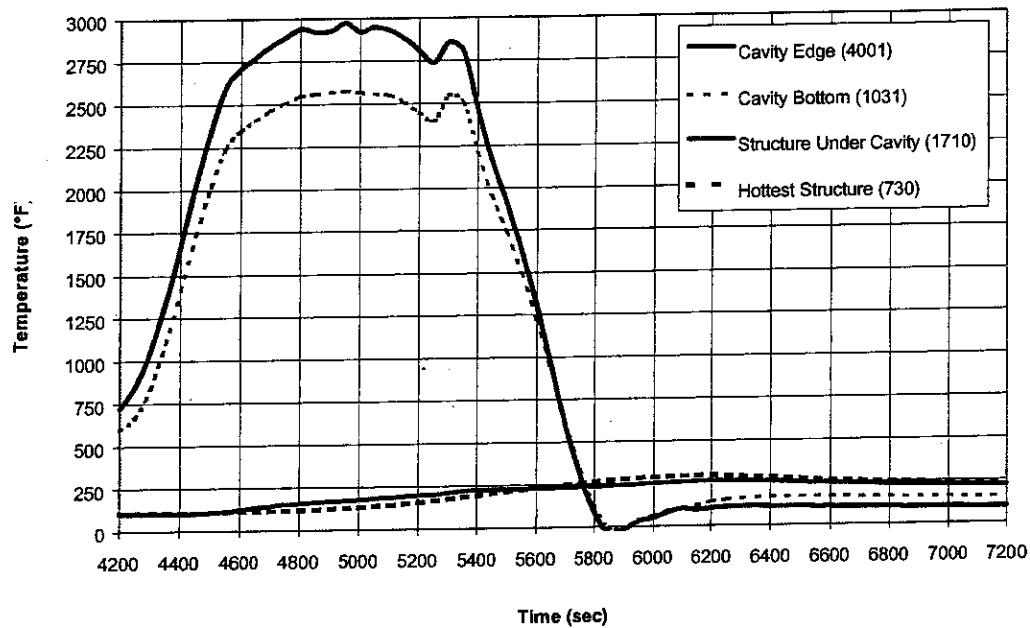
Figure 8 - STS-87 Temperature Results for TMM 99

The results of the evaluations are presented in Table 1 and Figure 8 through Figure 20. The STS-87 analysis resulted in TPS surface temperatures at the damage sites just above the melting point of the material. The local structure temperature results were all below material limits.

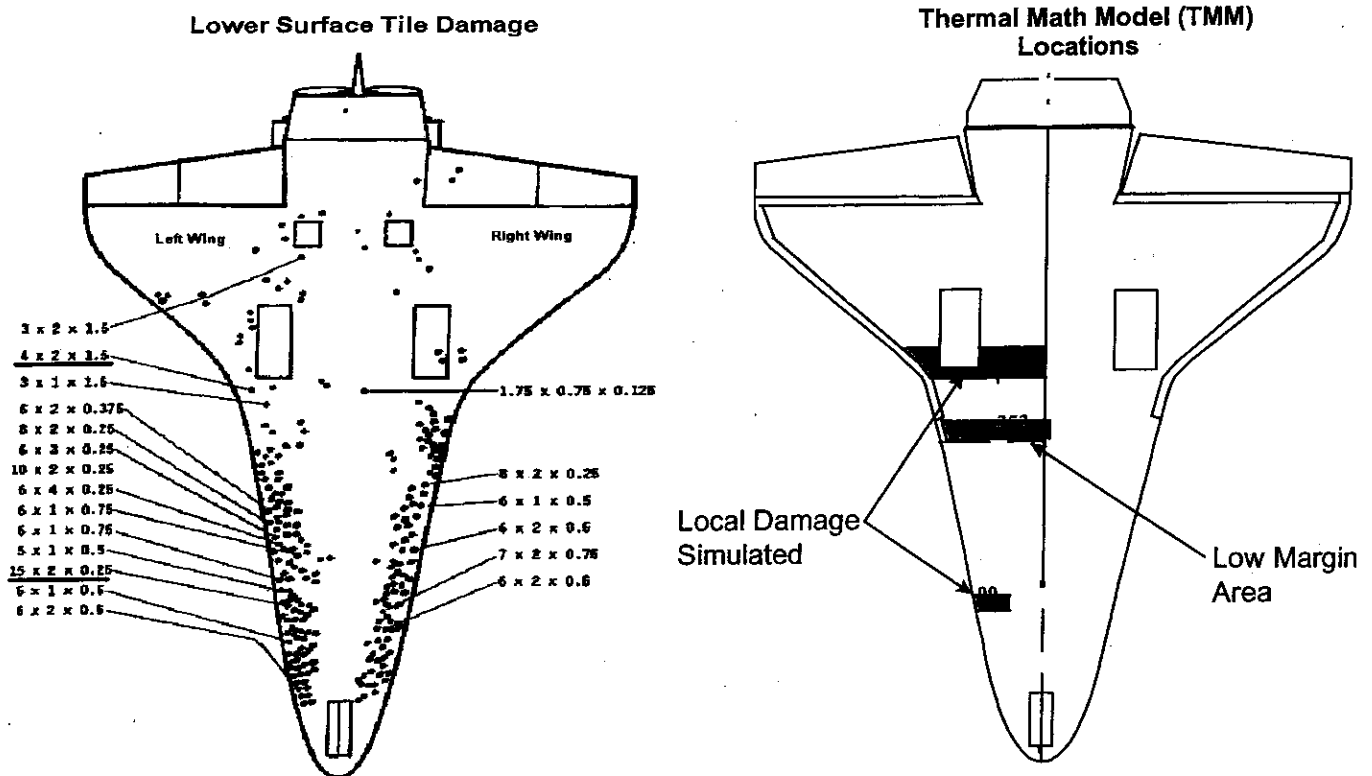
Figure 1 - Model Locations Chosen to Analyze Worst Damage Sites

To analyze the temperatures experienced by the OV-102 lower surface TPS, mission specific aeroheating was generated for EOM, and existing thermal math models (TMMs) were selected which covered the two worst damage areas. (See Figure 1). TMM 99, located on the lower wing glove, was chosen to simulate one of the longer damage sites, and TMM 352, located near the left main landing gear door, was chosen to cover the site of the deepest damage.

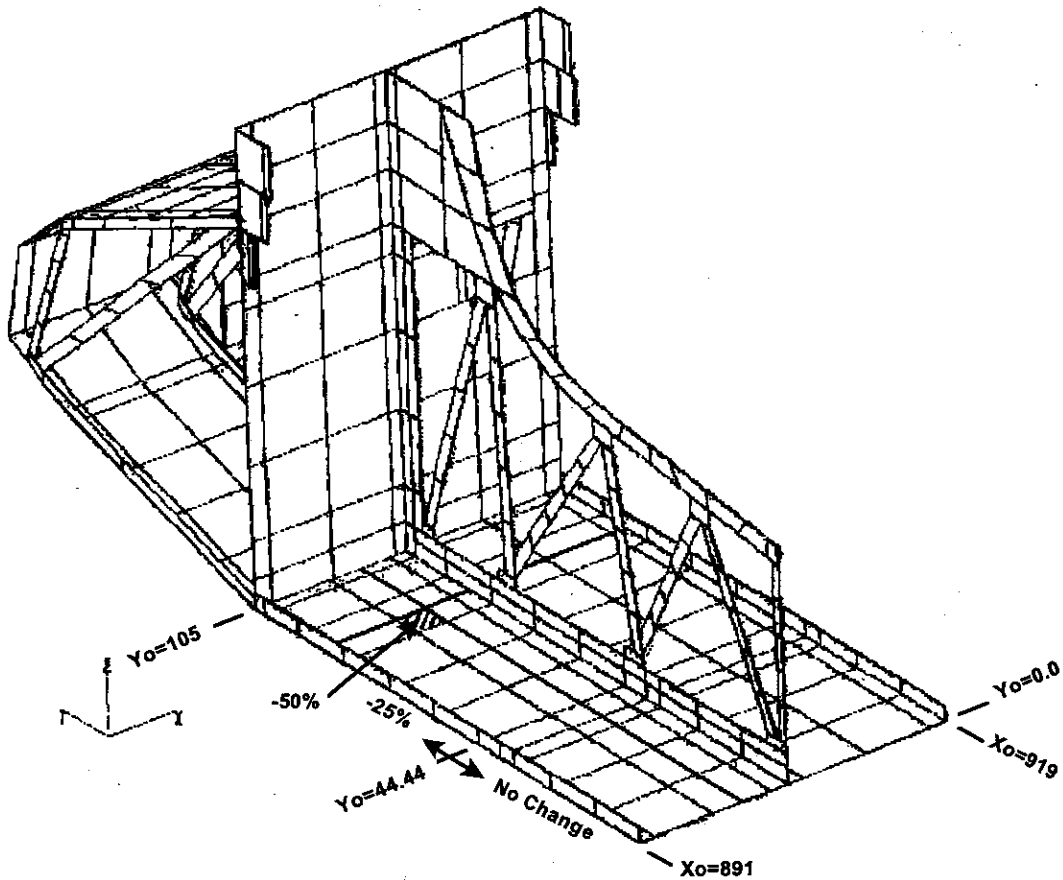
Figure 7 - Simulated Damage Location on TMM 353

Structural analysis identified temperature gradients at the bottom panel from the centerline to the side wall of the mid-fuselage bottom at Xo1050 as a critical margin area. TMM 353 was chosen to simulate extensive damage in this area. The analysis considered a 25% tile loss over one frame bay of the bottom. Within this area, one tile was reduced to 50% thickness. See Figure 7.

Evaluation of extensive damage on the outboard lower surface using TMM 353 indicated minimal tile damage. However, the structural temperatures and temperature gradients exceeded acceptable limits. The temperature results of this analysis were assessed by the structures group and their conclusion was that large in-plane gradients and thermal stresses result in unacceptable margins of safety.

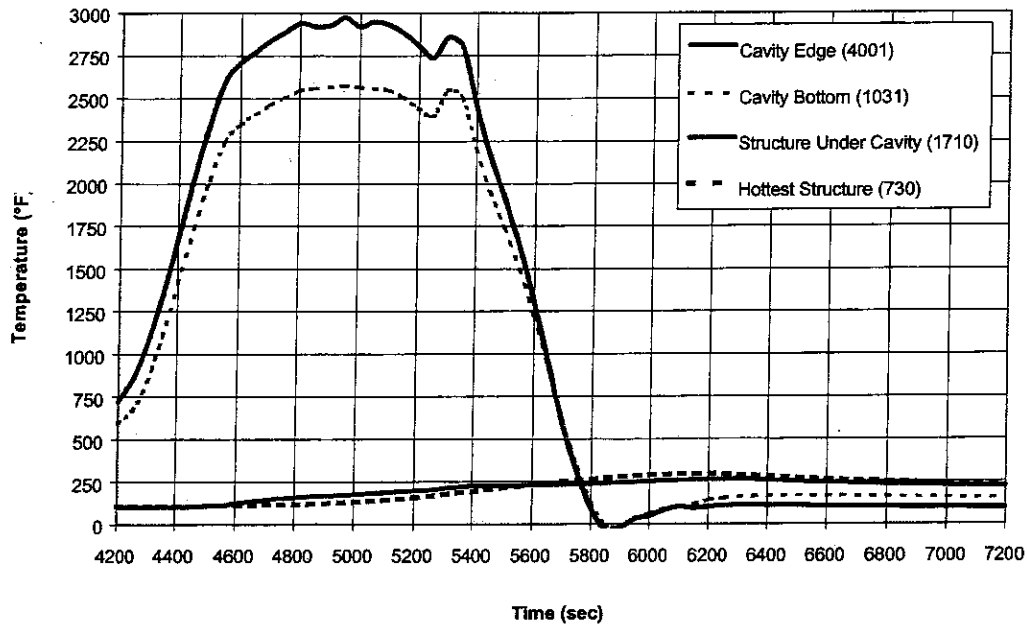
Figure 8 - STS-87 Temperature Results for TMM 99

The results of the evaluations are presented in Table 1 and Figure 8 through Figure 20. The STS-87 analysis resulted in TPS surface temperatures at the damage sites just above the melting point of the material. The local structure temperature results were all below material limits.
